PROGRESSIVE FATIGUE TESTING METHODS OF AIRCRAFT TURBINE ENGINE BLADE MATERIALS

Keywords: Nickel superalloy, Fatigue crack growth, Small specimen testing, Aircraft turbine blades

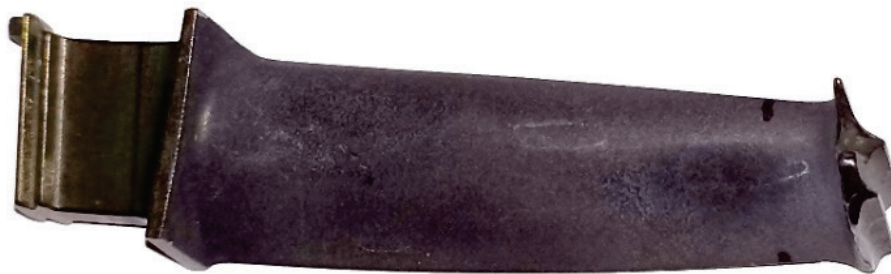
Three examples of the possible use of the mentioned methods above are presented. As a demonstrator a turbine blade of a helicopter turboshaft engine was chosen (Fig. 1).

Fig. 1: The turbine blade after the service life

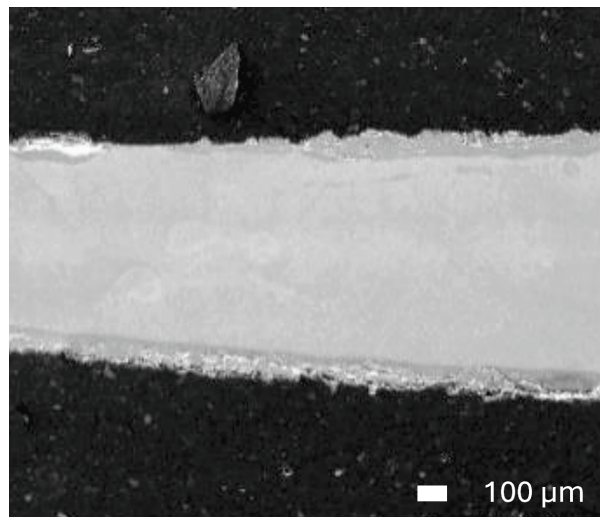
The first example shows the surface of the non-homogeneous protective layer (Fig 2), (Rohlová, 2017) after the general overhaul. The blade with the allowed interval of the protective layer thickness is determined by the type certificate holder, but usually only visual inspection and measurement of SEM results are performed. This type of image can be subjected to data classification procedures and after the overhaul procedure can be automatically defined as suitable or not suitable according to the allowed interval. Methods performed by Bartošák (2024) can bring more precise information about the mechanical degradation of overhauled blade and define whether the blade is airworthy or not.

Fig. 2: The turbine blade surface after the general overhaul

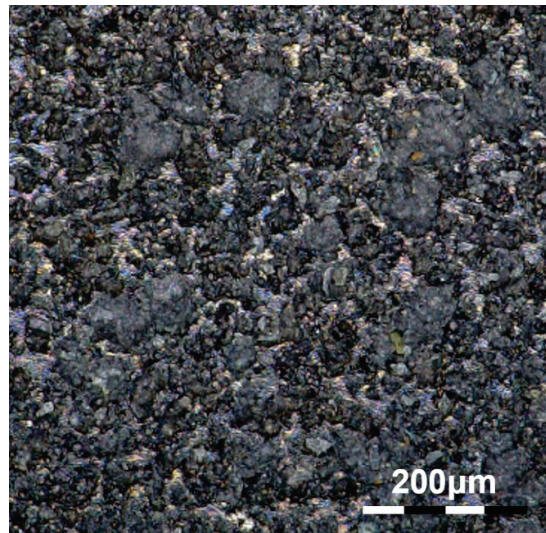
The second example shows the same type of the blade after the service life. Fig. 3 shows the surface degradation in deeper detail. The blade surface is full of specific non-homogeneous craters. Maximal observed diameter of these craters is 20μm with maximal depth 10μm.

Fig. 3: The turbine blade after the service life in detail

These craters were also observed in the blades during the operation. Knowledge of fatigue prediction defined by the first two methods, combined with data classification analysis, can determine whether turbine blade with specific degradation is still suitable or unsuitable for further operation.

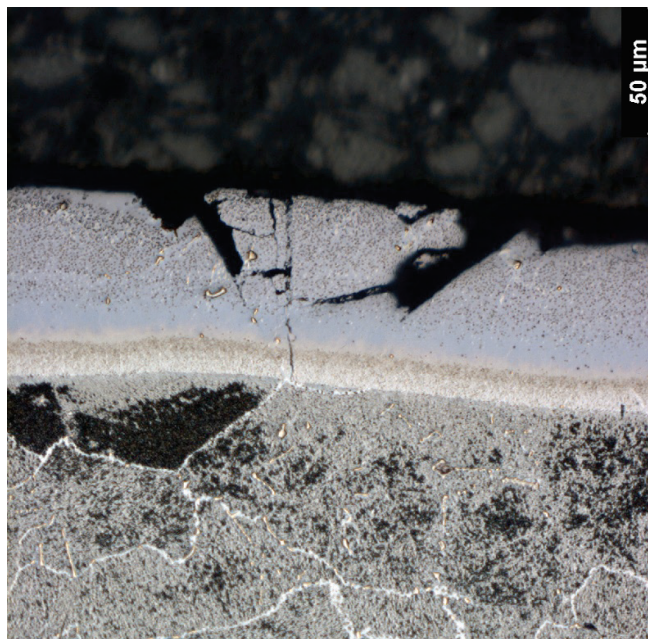
Another example of the possible using of automated microscope image analysis is show in Fig 4. The initial short fatigue cracks can grow from the protective layer to the basic material. Human factors significantly influence the NDT results, machine learning and data classification are applied to decrease the human errors such a false positive or false negative finding. Fatigue crack growth rate data can then help to define residual fatigue life and crack prediction.

Fig. 4: The protective layer of the turbine blade in detail after the service life
