## RESULTS OF A COMPARATIVE DAMAGE DETECTION CASE STUDY

**Abstract:** *A significant amount of attention has been devoted to rapid bridge testing in recent years at the Institute of Theoretical and Applied Mechanics. New methods, such as the Vehicle Scanning Method and Moving Impulse Load Testing, have been developed and/or tested on a scaled laboratory bridge model. This article summarizes all conducted tests, discusses the evaluation methods used, presents the results obtained, and explores possibilities for their improvement. Among the tested methods, the application of Moving Impulse Load (MIL) moving at slow speed, with an excitation frequency around the first natural frequency of the tested bridge, appears to be the most promising. Two passages of the MIL allow for an approximate estimation of the dominant natural frequencies, while repeated passages at small velocity increments provide an excellent means of detecting changes in structural stiffness.*

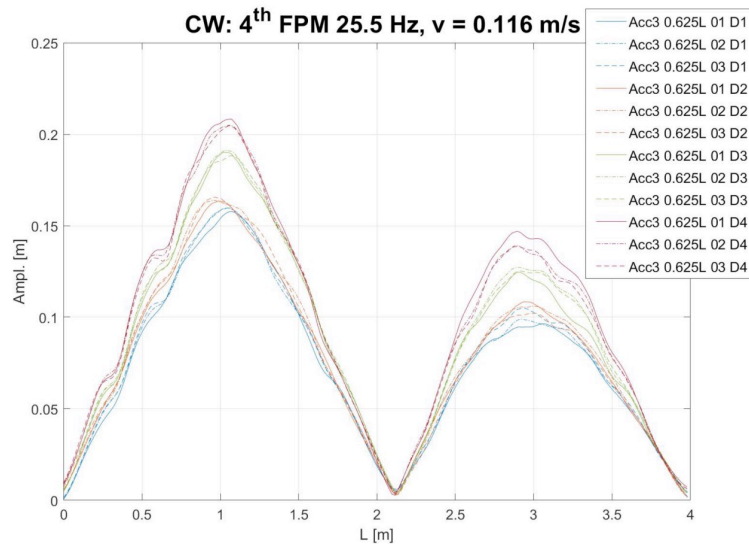
Fig. 2: Evaluated Forced Passage Modes at the 4<sup>th</sup> harmonic peak for all damage cases measured by accelerometer Acc3 at the position 0.625 of the span L for moving velocity 0.116 m/s.

4.2.4. Evaluation of forced passage modes (revealed clear systematic changes on selected harmonic frequencies see Fig. 2)

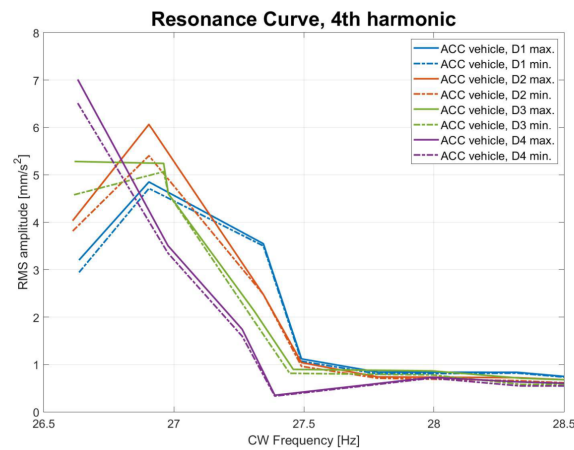
Fig. 3: Resonance curve evaluated for the fourth harmonic component using the CW&SV

This experiment is analogous to case 4.2. The advantage of this "drive-by" estimation comes at the cost of lower DR. Evaluations 4.2.1 – 4.2.4 could also be performed. The lower signal-to-noise ratio improves when distinctive bridge vibrations occur, such as in resonance conditions, allowing for clear differentiation between damage cases (see Fig.3). This evaluation can be conducted with even greater reliability within the framework of the 4.2 testing method.
